# Manhole Inspection Summary

Manhole # S53GG\_005MH

Insp Date: **6/6/08 9:45 AM**

**Location** Address: **Edison**

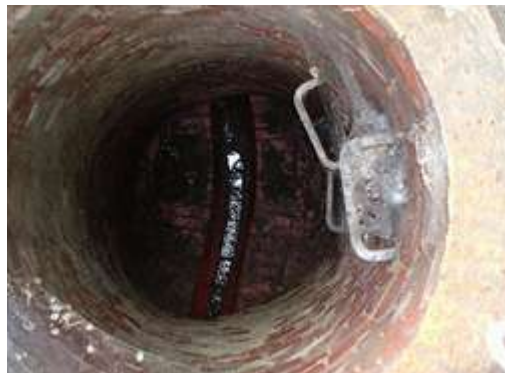
Top View

**Frame** Offset: **1** (in.) Condition: ☐ Sound ☐ Cracked ☒ **Leaks**

Infiltration: ☐ None ☐ Joint ☐ Cracks ☐ Mortar ☐ Roots ☒ **Wall**
